## Muffin - The Strip Down:

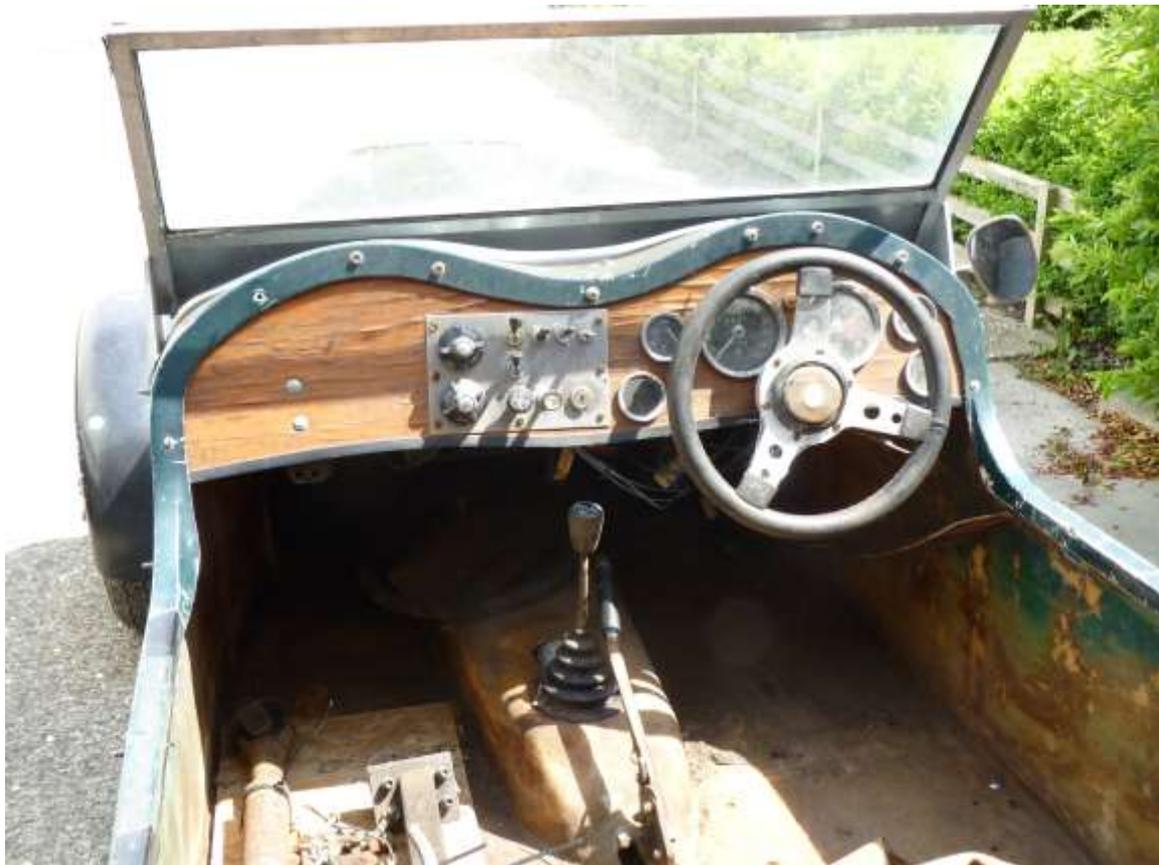
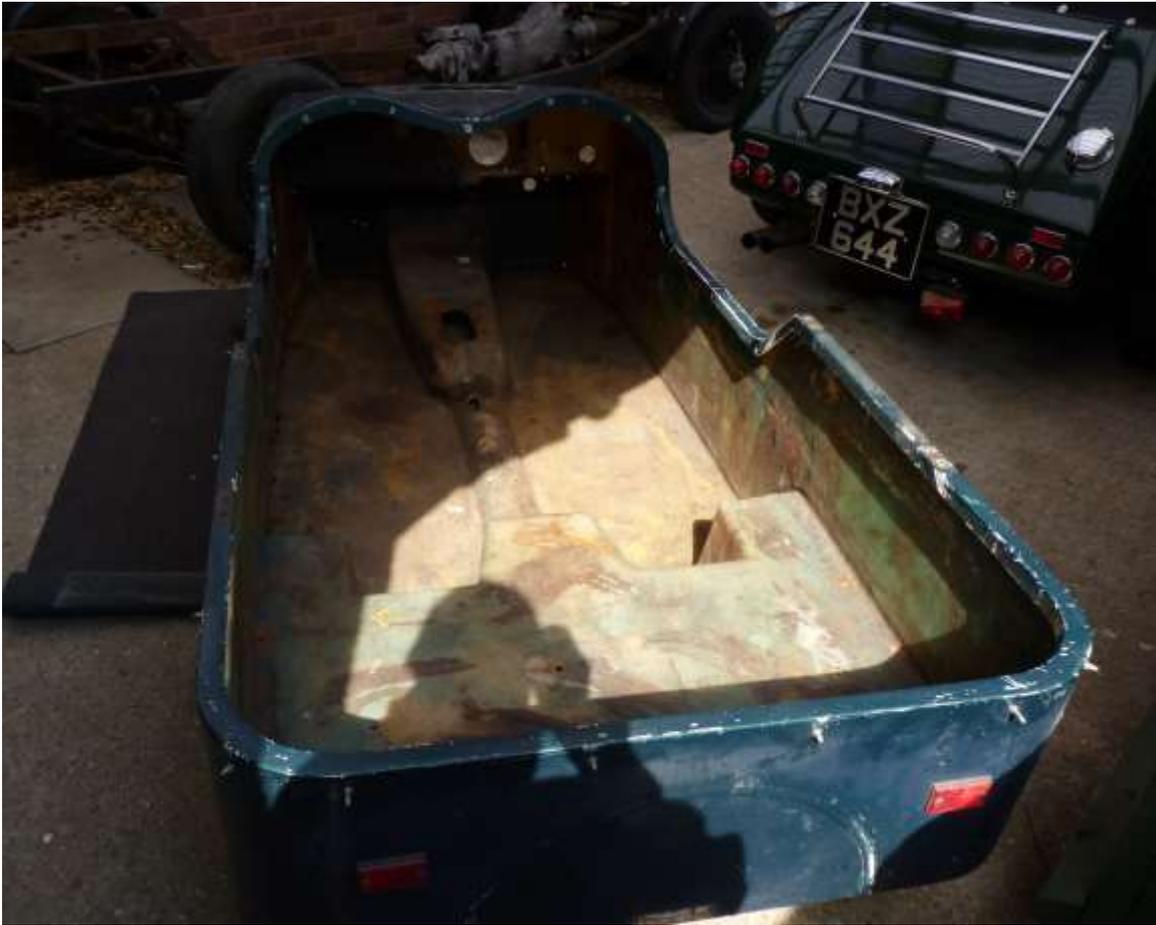
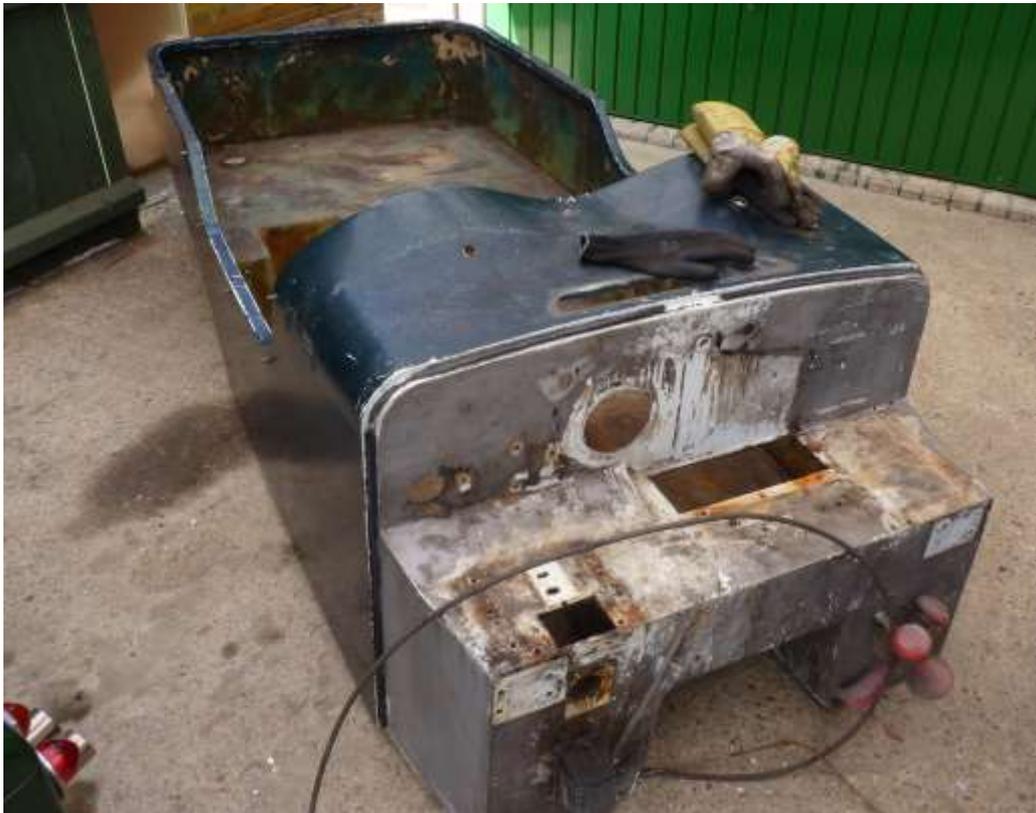
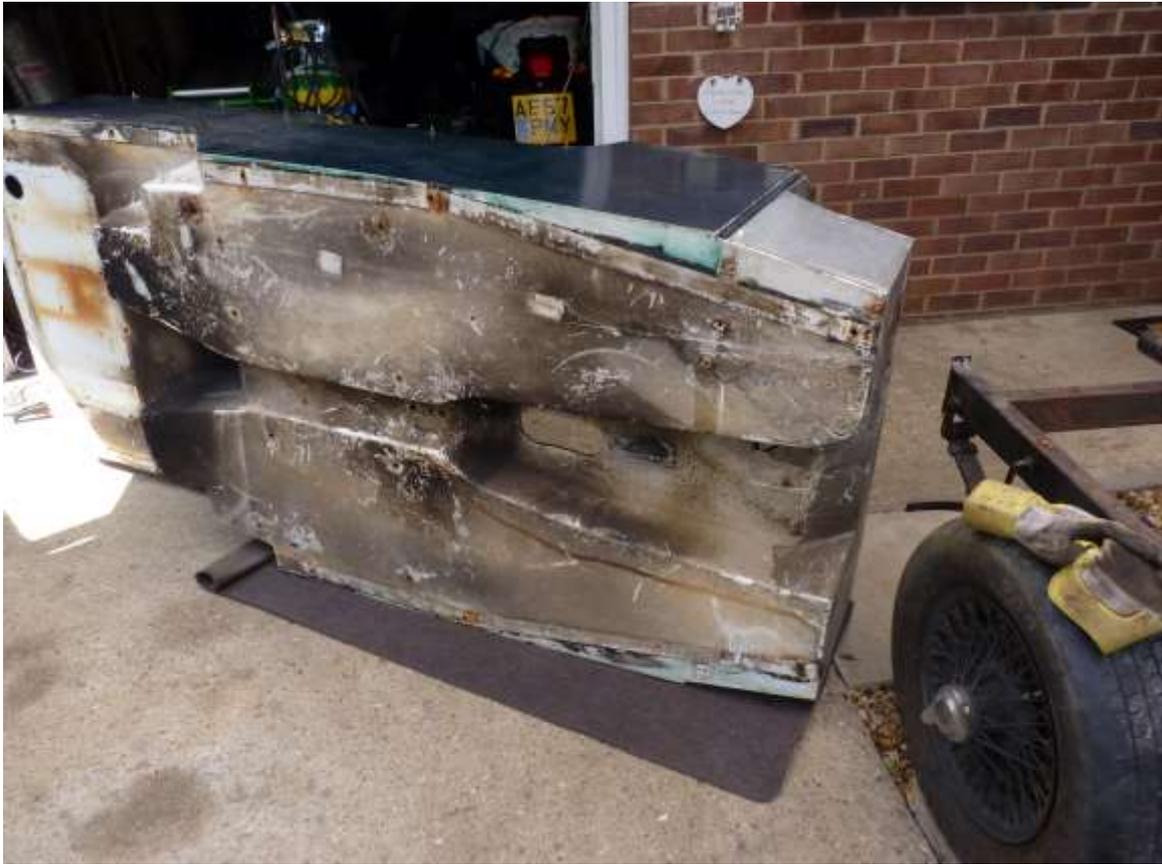
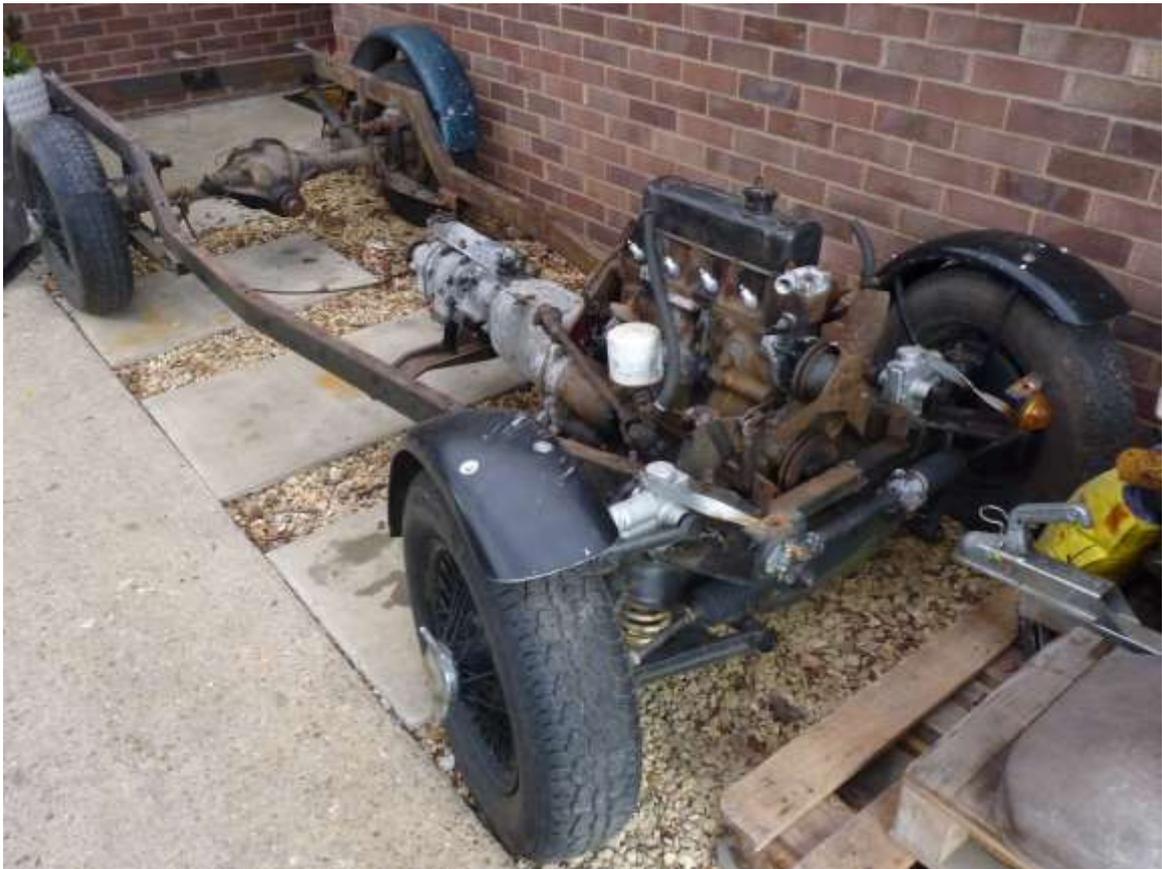
The photos were taken 48 hours after delivery. You will note that the chassis is well rusted. It looks rather basic compared to the later TA's as it doesn't have any cruciform bracing, but when you factor in the lack of cracks in both the chassis and the body it was obviously well up to the job. It's quite rusty due to the lack of post build care rather than the original design. Of course it wouldn't pass a current IVA Test but that's due to the introduction of new rules rather than any omissions by Nick Green. My master plan will see a considerable improvement in the chassis area.

The state of the engine is a bit disappointing and it was obviously left without antifreeze at some stage as two core plugs have blown, but I cannot see any cracks. When I drained the oil it looked like something out of the black lagoon but I intend to do a full engine strip and rebuild and get the cylinder head converted to unleaded.

The gearbox is the overdrive type but it doesn't look like the overdrive unit has ever been connected. There is also a hole in the gearbox bell housing adjacent to the starter motor. As I now have four overdrive type gearboxes a solution will no doubt be found.
