Emma's Cooling System:

I recently described how I fitted a thermostatic sender unit to switch the power On/Off for the electric cooling fan; at the same time I mentioned I was overhauling the cooling system. This post is a follow up and describes the remaining work on the cooling system

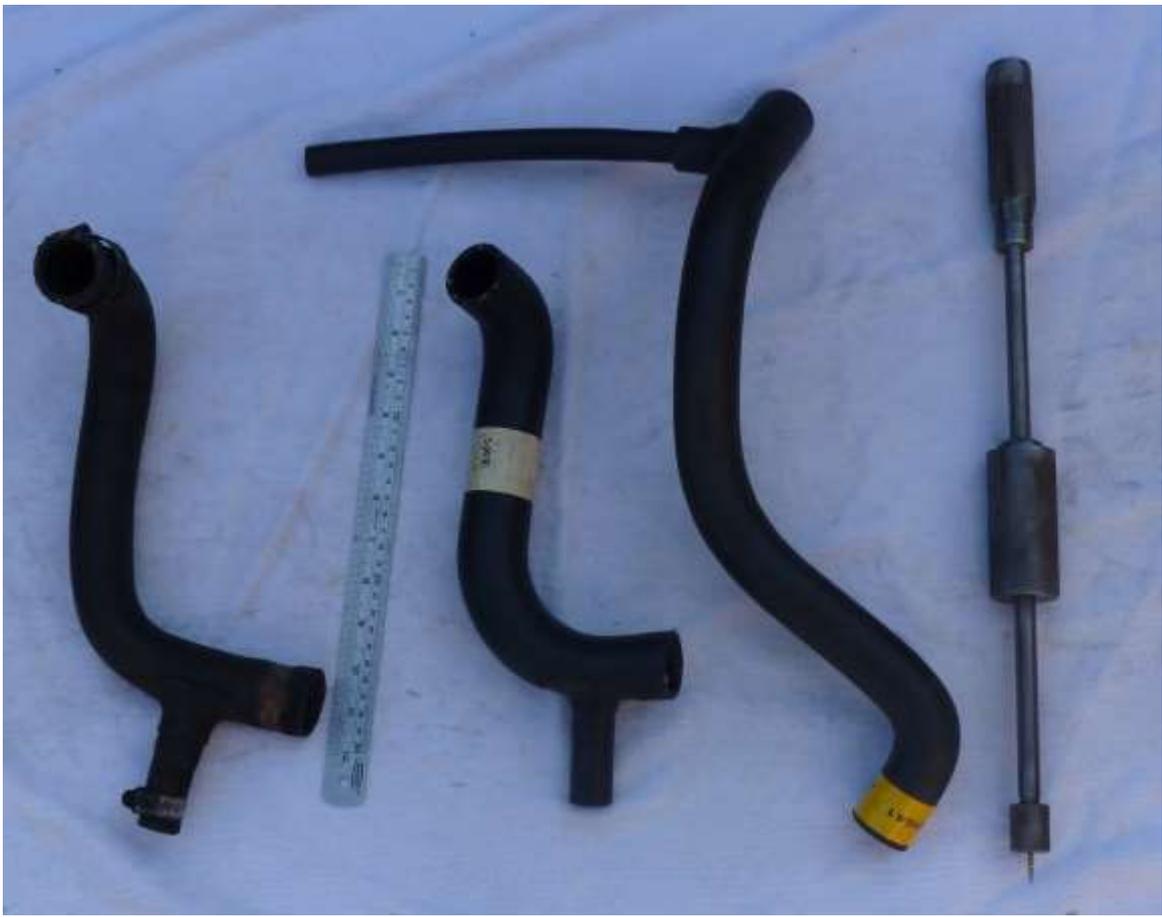
In the photo below the original hose is on the left, the Landcrab hose is in the centre and the MGB hose is on the right. To the right of that is the slide hammer I made in the early seventies. It doesn't get a lot of use but it's very handy occasionally.

Prior to starting the work I had asked 'Dan L' (the previous owner), if he knew the origin of the bottom hose, he couldn't remember but thought it may have been supplied as part of his original kit. I then asked a Group question regarding the identity of the bottom hose and following the two suggestions of Mini and late model MGB I checked out both hose shapes on the Internet. The one that looked closest was for a Mini so I ordered one; as soon as it arrived I realised it was the wrong one and returned it. John Hoyle was the original supplier of the kit so I emailed him; John informed me that he had supplied the later MGB hoses (part number GRH-641), with some kits so I ordered one from Moss Europe Ltd. for £18.12 including postage, it was not a straight fit to my Landcrab radiator, but I could have modified it to fit. Unfortunately it is NOT a Silicone hose.

The annoying thing is that the bottom hose I removed is just about a perfect fit, but what was it originally fitted to? A brief conversation with Mark Sadler revealed all; it is the bottom hose from an Austin Morris Landcrab. The annoying thing was that initially I thought of trying a Landcrab hose but knew they had a transverse engine and my feeble mind had put the radiator in the front grill which meant a long and tortuously shaped hose. Immediately Mark mentioned that he had used a Landcrab hose my mind went back almost 50 years to my brother-in-laws Landcrab and in my minds eye I could clearly see the radiator, in its rightful position along the left hand inner mudguard. After Mark's suggestion I went straight on eBay and got a NOS AC Delco hose, part number 'RH1170' for £10 with free postage. Success at last it is slightly different from my original

hose (different after market supplier perhaps), it is a perfect fit without modification. "Thanks Mark!"
