Rufus - Bonnet Modifications:

Introduction:

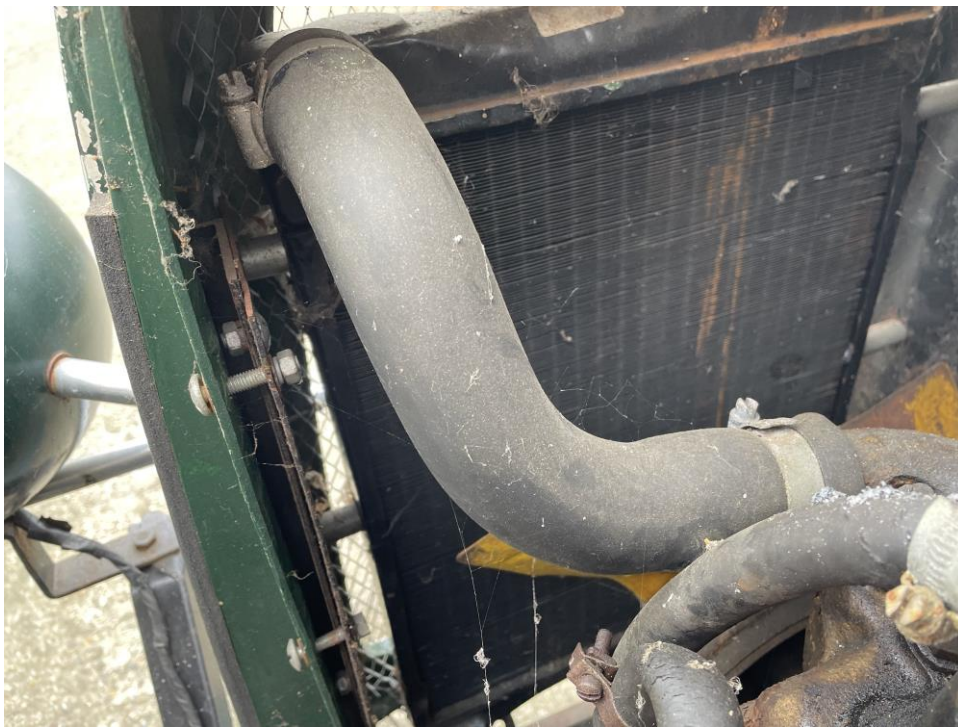
Original setup, not the best of installations or fixings.

The radiator installation was a bodge. I had a very good Austin/Morris Land-Crab radiator for which I made up new brackets out of flat steel plate. It was such a good fit that I think that the TA chassis must have been designed around that radiator? The build instructions that I obtained don't mention the source of the radiator although they do suggest fitting using the original Austin / Morris 1800 fixings. ***WAS THERE A SEPARATE LIST OF NON MGB PARTS REQUIRED?***

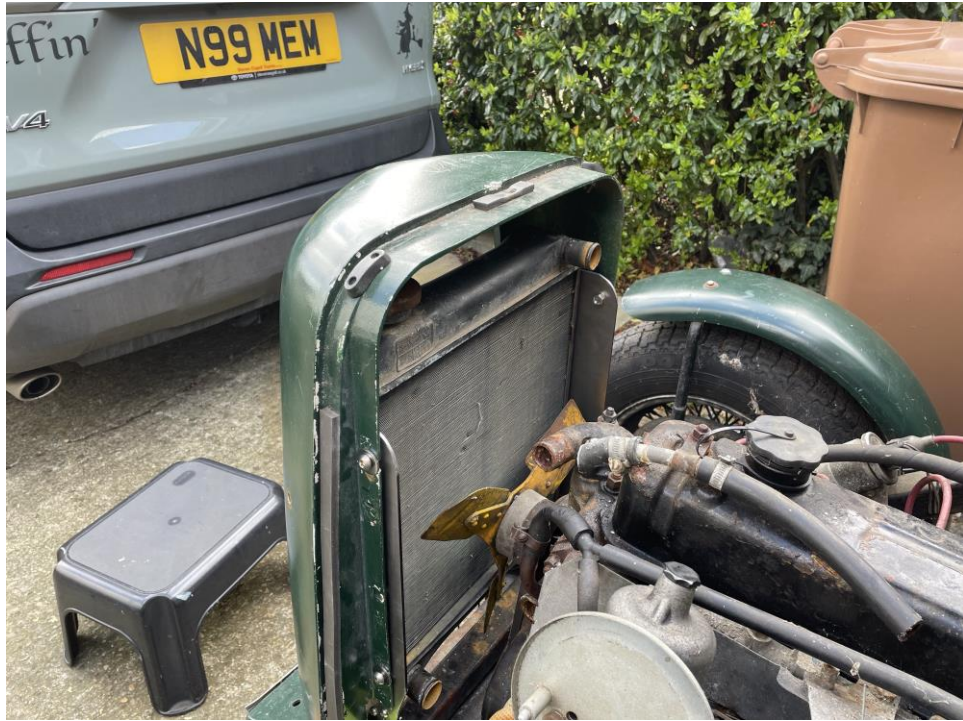
Trial fit with the Land-Crab radiator and new brackets.

The radiator cowl was a relatively easy fit onto the new brackets. There was a 3mm gap on each side between the radiator cowl and the flat plate and this gap will be taken up with 3mm thick self adhesive solid rubber strip during final assembly. To allow some adjustment for a good bonnet fit I slotted the holes in the cowl which allows the cowl to move forward and back.

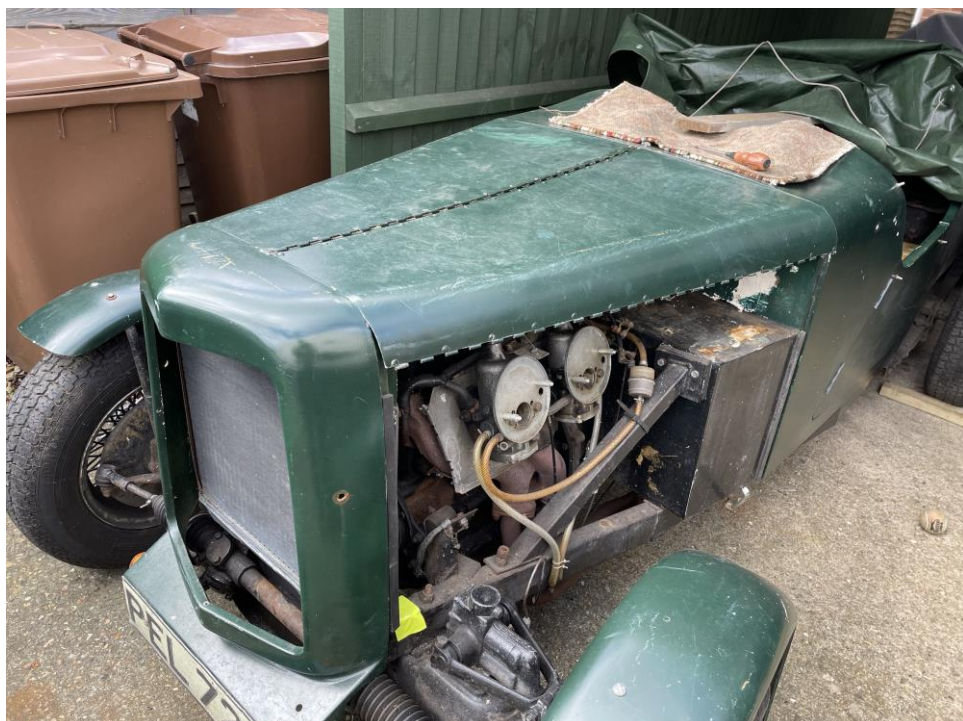
Hinge pins removed.

Always one for the easy option I removed the hinge pins to get four separate bonnet sections that could be more easily worked. Removal was by tapping them with a pin punch at one end so that the pin protruded from the other end sufficient to enable a pair of old mole grips to get a good grip. The mole grips were then tapped with a rubber mallet until the pins were out.

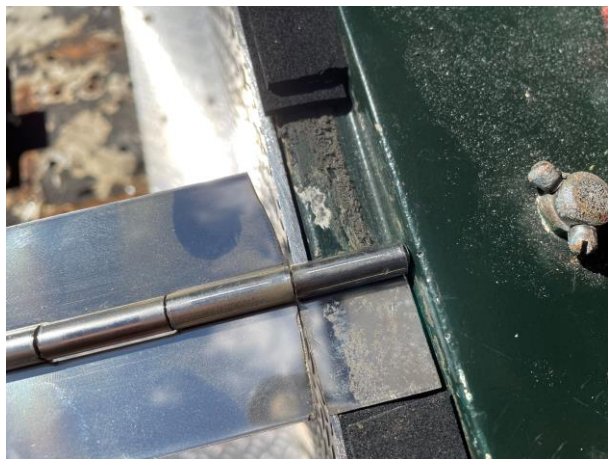
Rear fixing.

5. Two small pieces of hinge were then cut to act as the front and rear pivots.

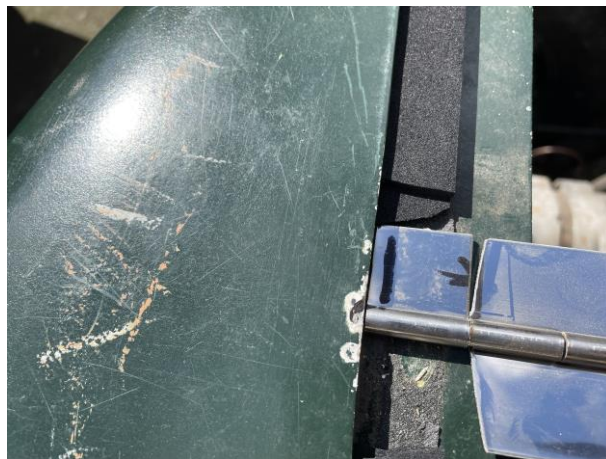
Front fixing.

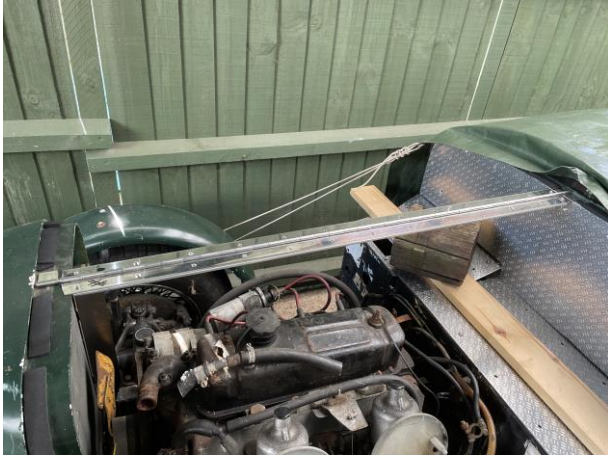
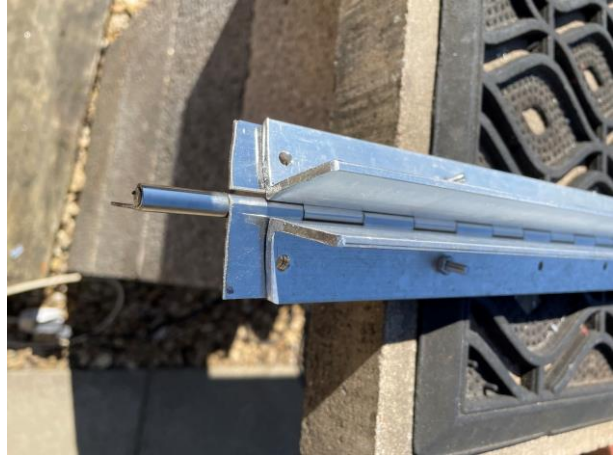
Mock up of hinge assembly. Details of aluminium angle hinge strengtheners (before final fettling).

Luckily I had an amount of aluminium moulding and 1" x 1/8" equal angle (to strengthen the hinge) left over from other projects and managed to retrieve enough to sort out the whole bonnet apart from the lower edges of both side panels (which probably won't need any moulding). The photos should explain all. I must admit that the 1" x 1/16" aluminium strip used to cover the excess holes next to the hinge looks a bit odd and sticks out like a pimple on a bulldogs gonads, I am trying to imagine what it would look like painted cream, if I'm not happy with it when it's painted I'll remake the top two bonnet sections.

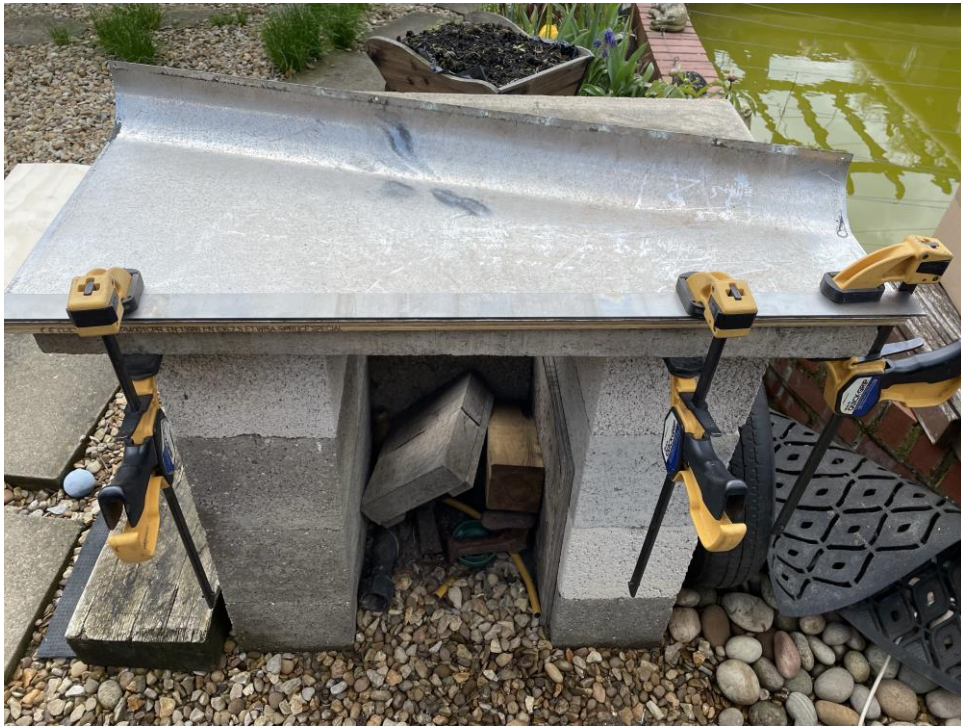
One way to get a nice straight edge.

6. The centre hinge was then laid in position.
7. The two bonnet top sections were then offered up against the hinge and I decided to take a 2mm strip off each side to allow for the thicker hinge pin and give a better fit at the sides.
8. After clamping a steel strip 2mm in from the edge of the bonnet centre (photo) I filed the aluminium flush to the edge of the steel strip (adjusting the clamp positions as I moved along) which gave a nice straight edge.

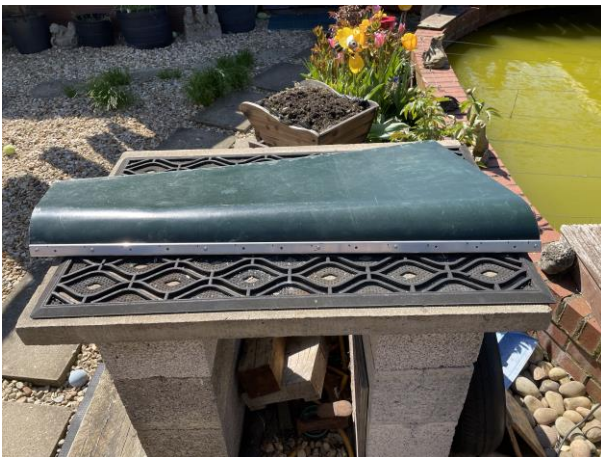
Ditto.

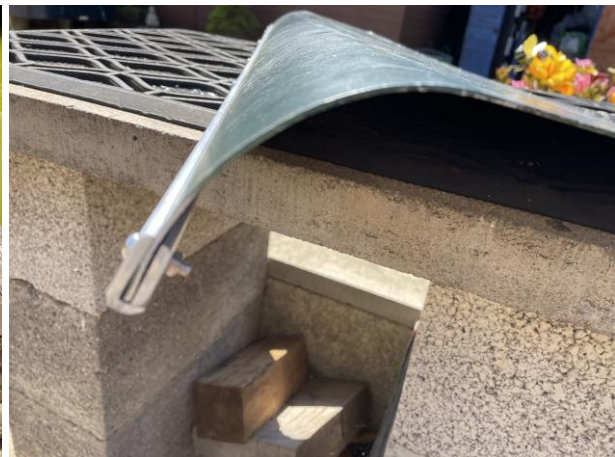
Strengthening aluminium moulding on the side of the bonnet.

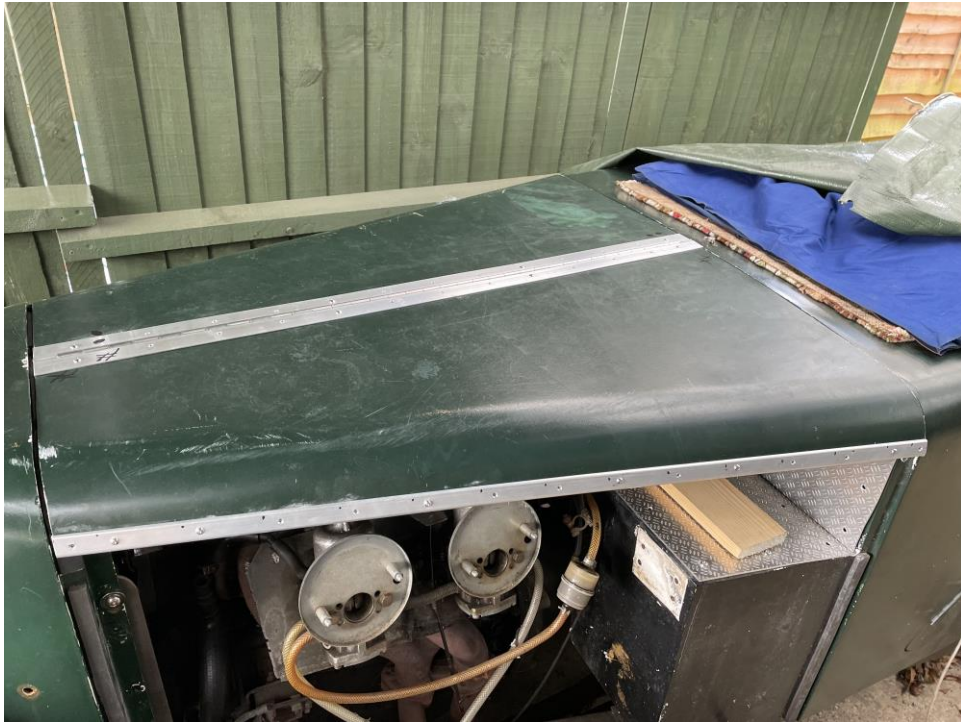
Bonnet trial fitted.

The bonnet will be secured to the side panels by short leather straps.

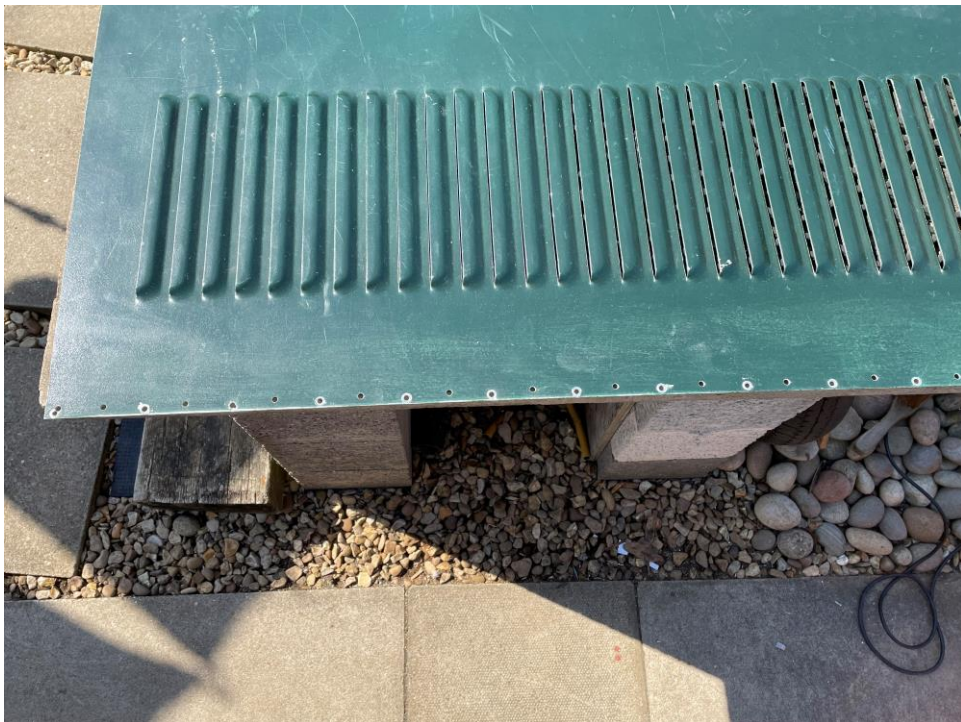
Old and new holes in the side panel.

As they were originally hinged to the bonnet the side panels had a row of hinge holes along each top edge. To disguise them I fitted some aluminium moulding which also strengthened the top edge and acted as a support for the centre bonnet panels. The photos should be self explanatory.

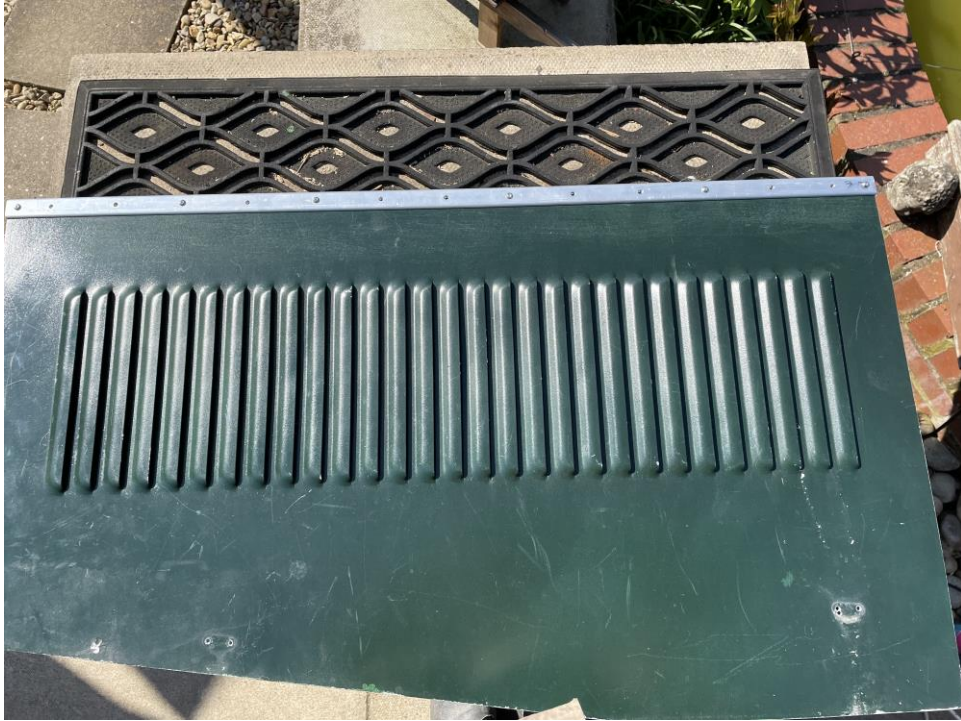
Side panel mouldings to disguise holes.

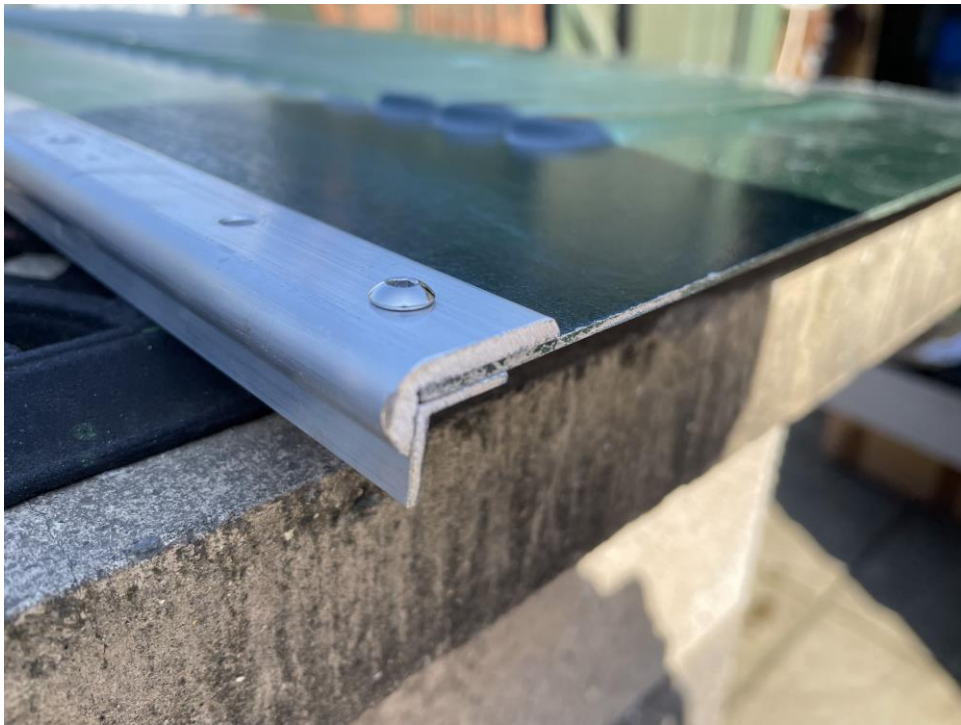
Ditto.
