## **Rufus - Aluminium Bulkhead Part 2.**

### **Introduction:**

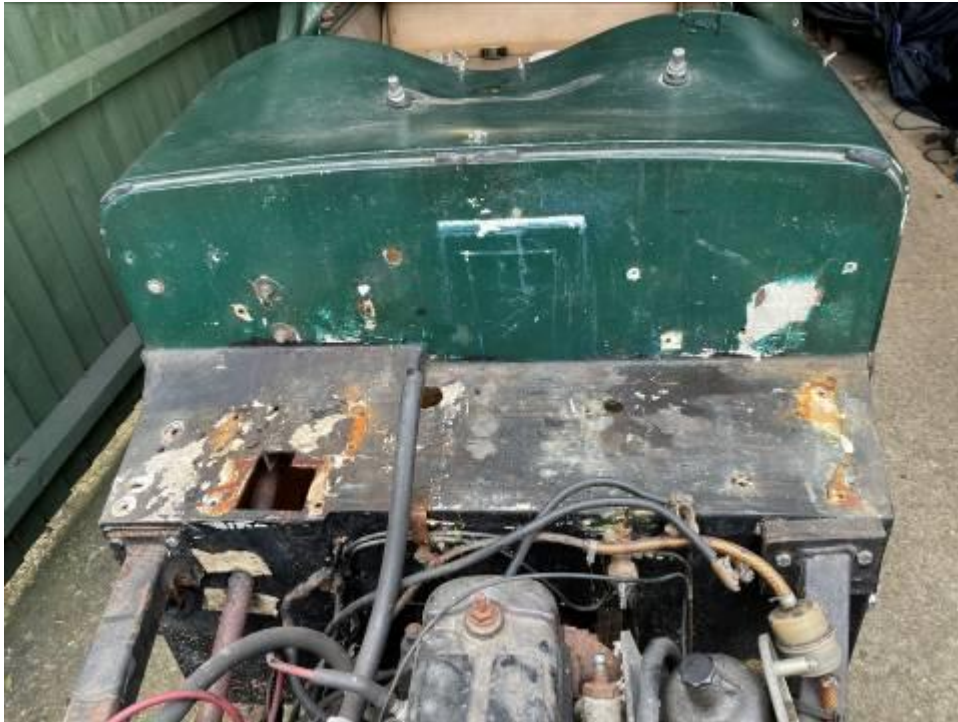
The fibreglass bulkhead had numerous unwanted holes, additionally both the clutch and brake pedals had been fitted to the left side of the steering column, which after I re-located the pedal box (to put a pedal either side) left an oversize pedal aperture hole.

**How it was.**

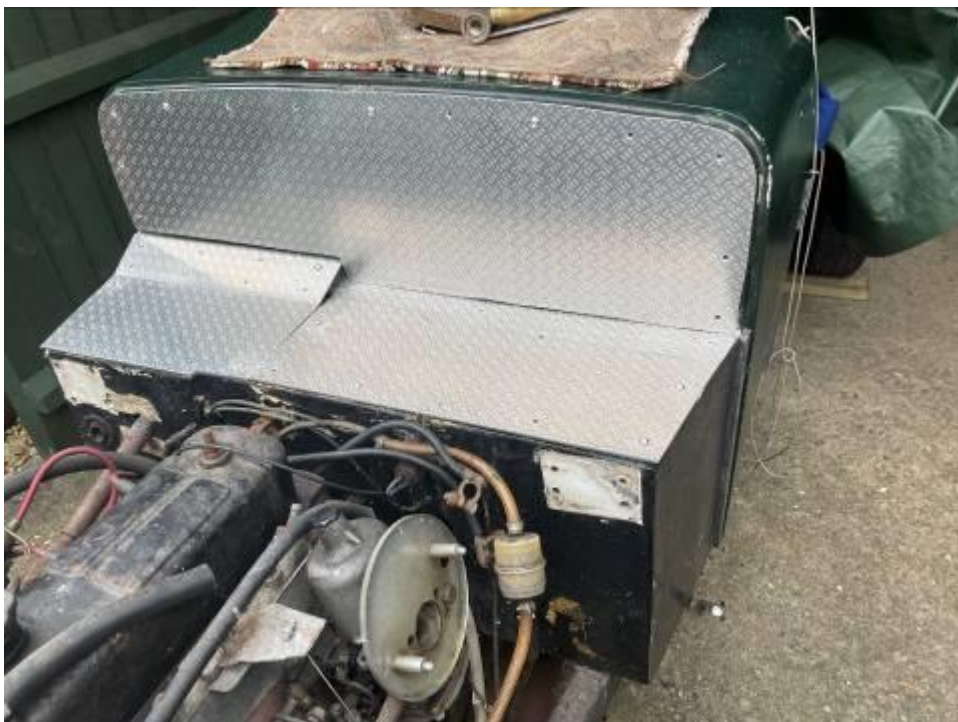
**Trial fitment of the completed panels.**

I decided to use small pattern aluminium chequer plate to disguise the holes and strengthen the bulkhead. The first part of this article described the making of the four aluminium panels. This article completes the job.

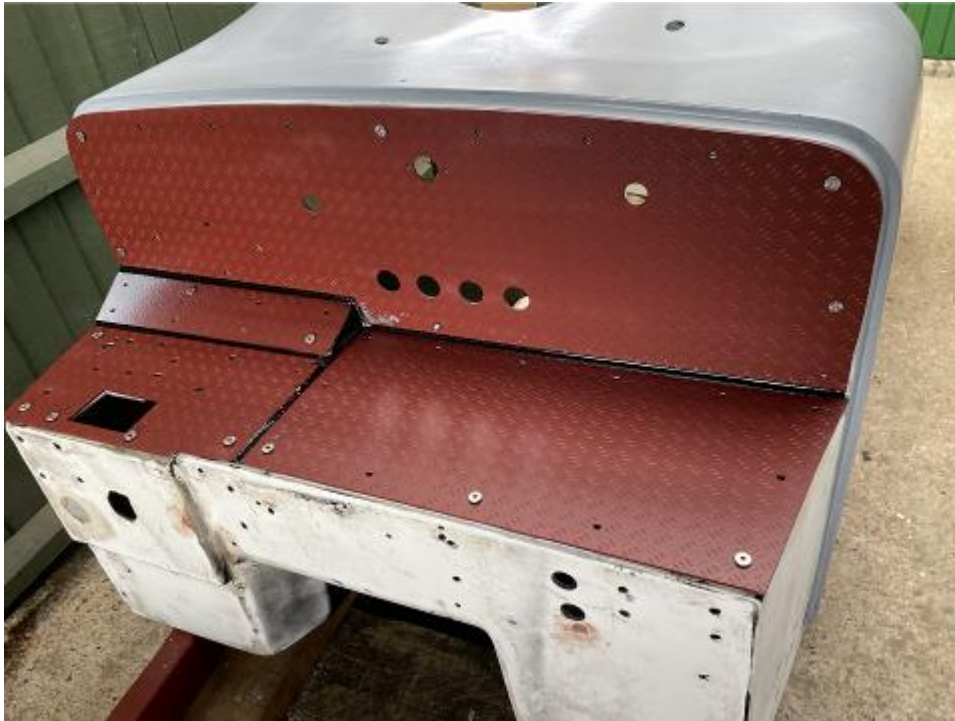
**The seams are all sealed.**

Working with any form of mastic is a job I hate, so I cheat whenever possible by applying masking tape to confine the seam sealer in its intended position..

With the masking tape in place I applied the seam sealer then smoothed it with a finger before leaving it to dry for twenty four hours.

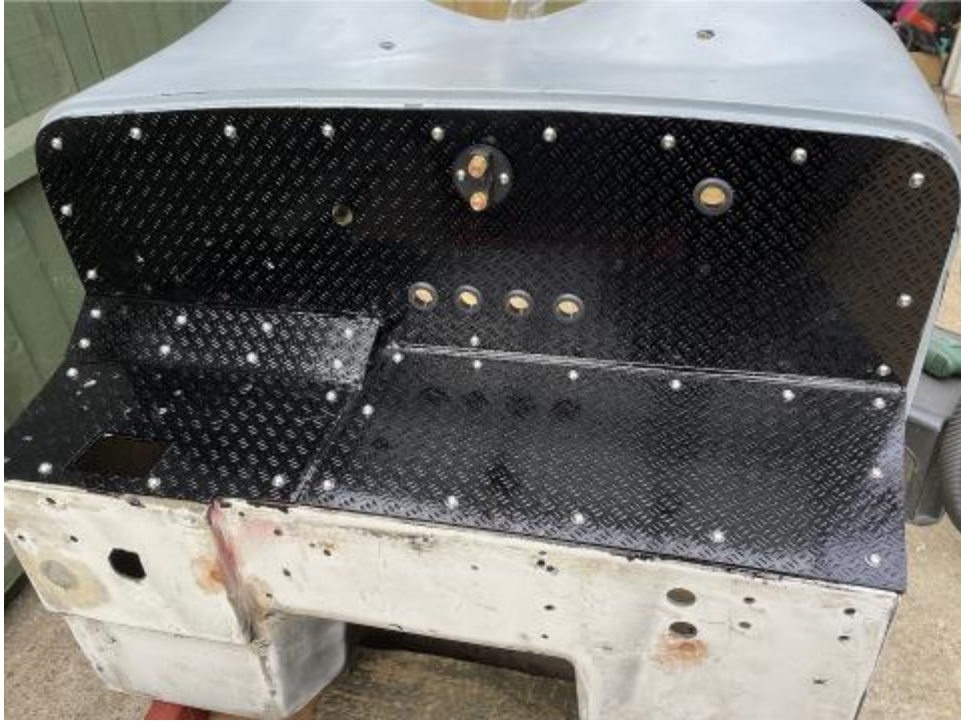
**Sorry about the reflections.**

After leaving the top coat of paint to harden for another 48 hours I fitted the M6 stainless steel button head screws (replacing the temporary countersunk ones as appropriate). I fitted a normal washer under the button head and an M20 washer (against the fibreglass) securing the assembly with a Ny-Loc nut.

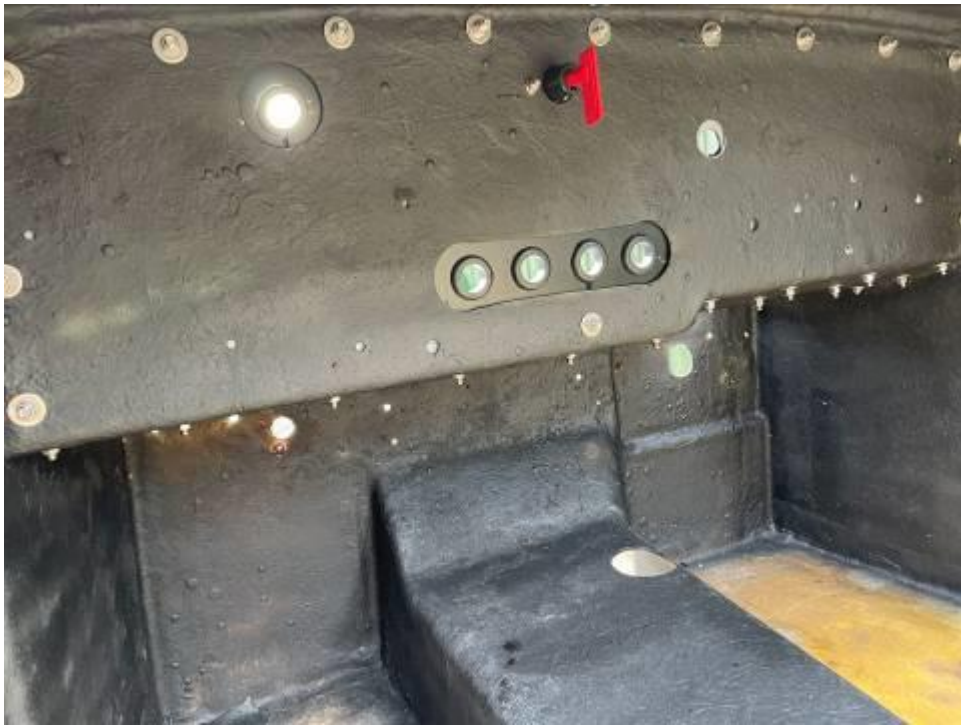
**Note that the cut-outs in the fibreglass allow the grommets to fit in the chequer plate only.**
